Challenge

Boggart Hole Clough lake was lined with concrete and brick, lacked planting and opportunities for wildlife. The water quality was lacking due to the absence of circulation and aquatic life. In 2014, poor water quality and anaerobic conditions led to a serious outbraeak of avian botulism, resulting in many casualties.

Solution

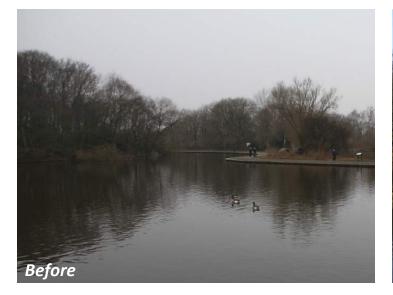
Even small trees can be planted on the island

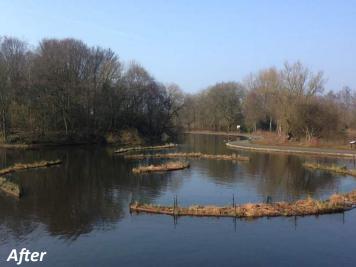
Varied planting provides an interesting image with colours shifting throughout the season

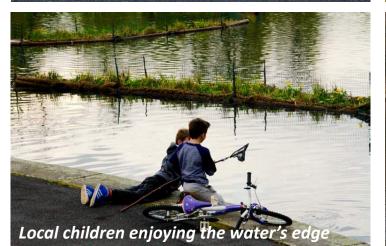
Taking water samples
